DEPARTMENT OF TRANSPORTATION**DIVISION OF ENGINEERING SERVICES**

Office of Structural Materials

Quality Assurance and Source Inspection

Contract #: 04-0120F4Cty: SF/ALA Rte: 80 PM: 13.2/13.9File #: 69.28**WELDING INSPECTION REPORT****Resident Engineer:**Siegenthaler, Peter**Address:** 333 Burma Road**City:** Oakland, CA 94607**Report No:** WIR-017085**Date Inspected:** 26-Sep-2010**Project Name:** SAS Superstructure**OSM Arrival Time:** 700**Prime Contractor:** American Bridge/Fluor Enterprises, a JV**OSM Departure Time:** 1900**Contractor:** Zhenhua Port Machinery Company, Ltd (ZPMC), Changxing Island **Location:** Shanghai, China**CWI Name:** Liu Hua Jie**CWI Present:** Yes No**Inspected CWI report:** Yes No N/A**Rod Oven in Use:** Yes No N/A**Electrode to specification:** Yes No N/A**Weld Procedures Followed:** Yes No N/A**Qualified Welders:** Yes No N/A**Verified Joint Fit-up:** Yes No N/A**Approved Drawings:** Yes No N/A**Approved WPS:** Yes No N/A**Delayed / Cancelled:** Yes No N/A**Bridge No:** 34-0006**Component:** Orthotropic Box Girder(OBG)**Summary of Items Observed:**

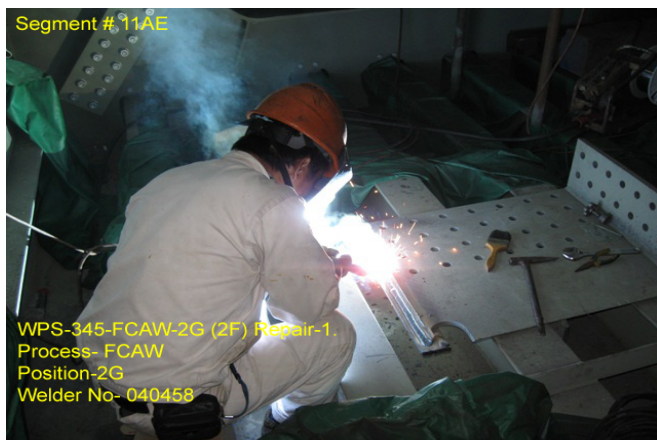
Segment # 11AE**Repair Welding**

This QA inspector observed, ZPMC qualified welding personnel identified as 040458 perform Flux Core Arc Welding (FCAW), Build up Small Longitudinal Diaphragm. Longitudinal Diaphragm identified as LD15E; The Welding Repair Report (WRR) was B-WR15055.ZPMC QC is identified as Mr. Wang Li Yang. The welding parameters measured using QC's calibrated instrument appeared to be in general compliance with WPS-345-FCAW-2G (2F) Repair-1.See the attached Photo.

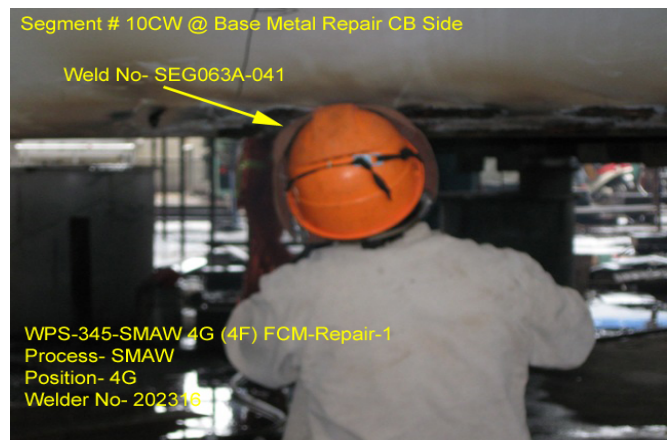
Segment # 10CE

This QA inspector observed, ZPMC qualified welding personnel identified as 202316 perform Shielded Metal Arc Welding (SMAW), weld joint identified as SEG063A-041; The Critical Welding Repair Report (CWRR) was B-CWR1835. ZPMC QC is identified as Mr. Wang Li Yang. The welding parameters measured using QC's calibrated instrument appeared to be in general compliance with WPS-345-SMAW-4G (4F) FCM-Repair-1. See the attached Photo.
